# VEHICLE INSPECTION REPORT

**VX16AEE**

## Dennis Elite 6

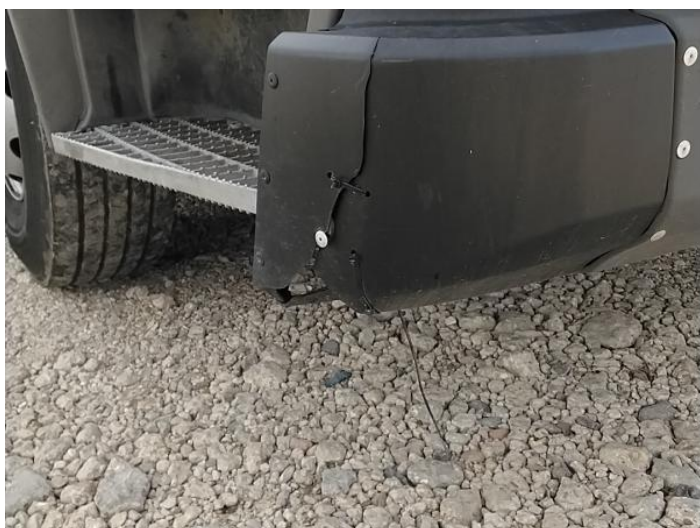
1: Bumper Front Moulding  
Broken  
Replace

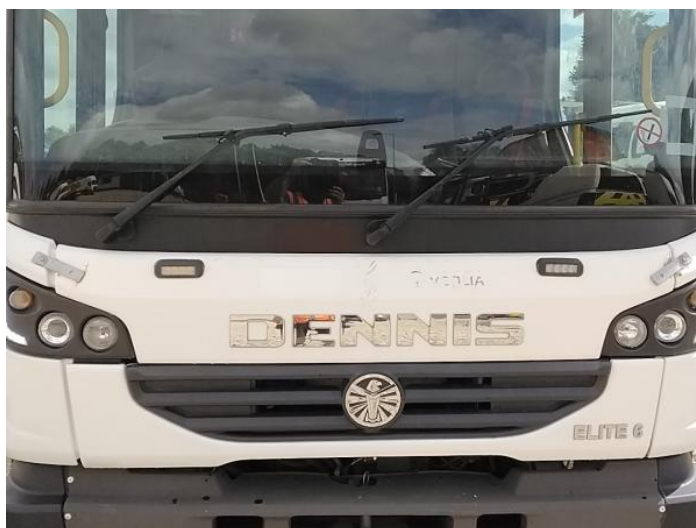
2: Bonnet  
Scratched  
UpTo 25mm Thru Paint

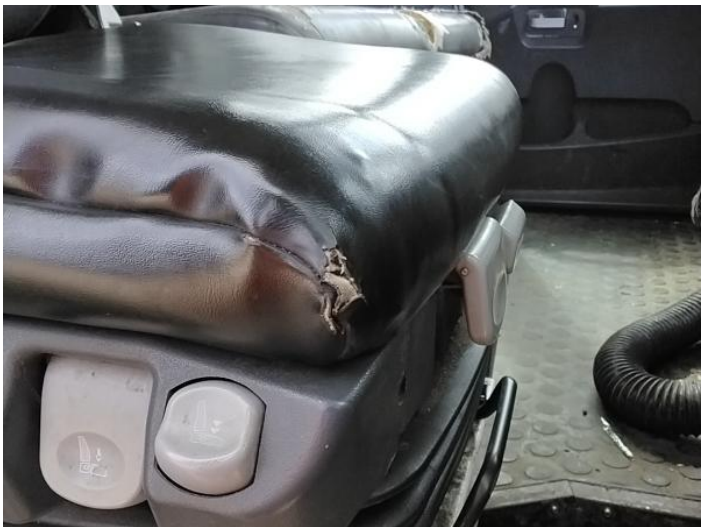
22: Seat Base Cover osf  
Holed  
Over 3mm

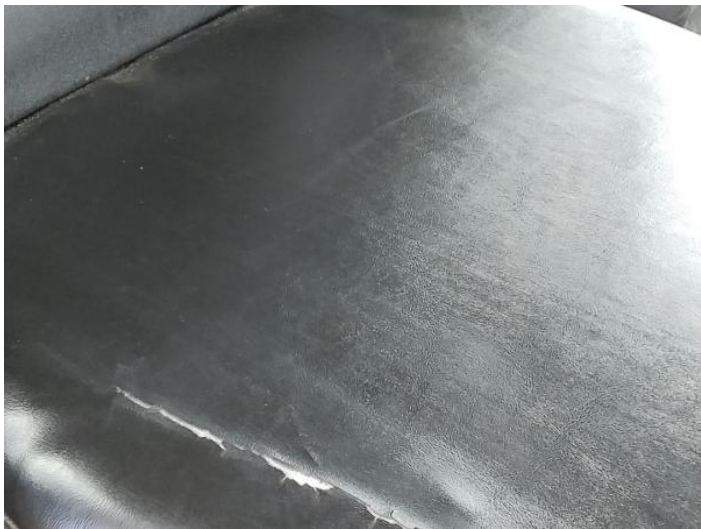
23: Seat Base Cover osf  
Torn  
Over 3mm
