# VEHICLE INSPECTION REPORT

**GF63SKJ**

## Ford Transit 2.2

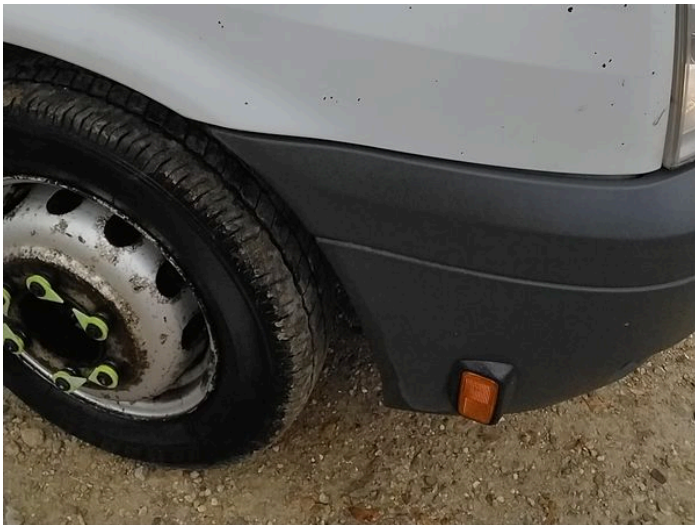
1: Wing osf  
Chipped  
Multiple Chips

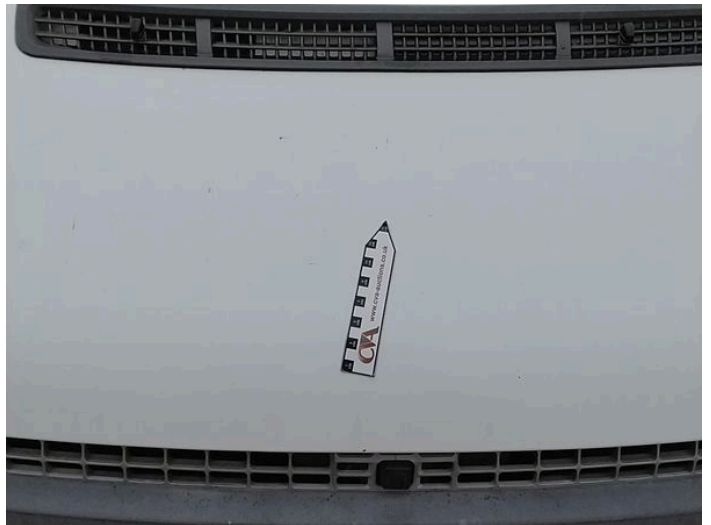
2: Bonnet  
Chipped  
Multiple Chips

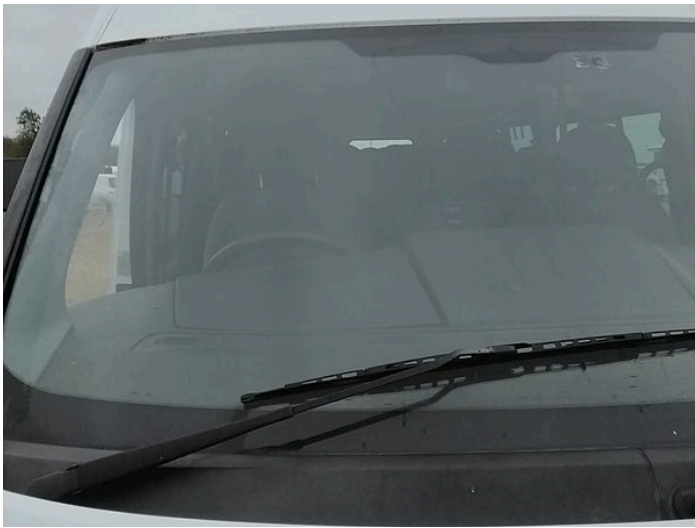
3: Screen Front  
Chipped  
Over 10mm

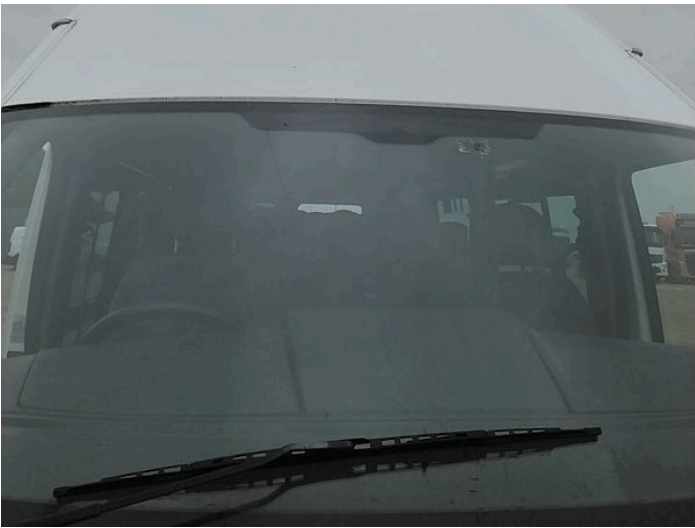
4: Roof  
Rusted  
Over 5mm

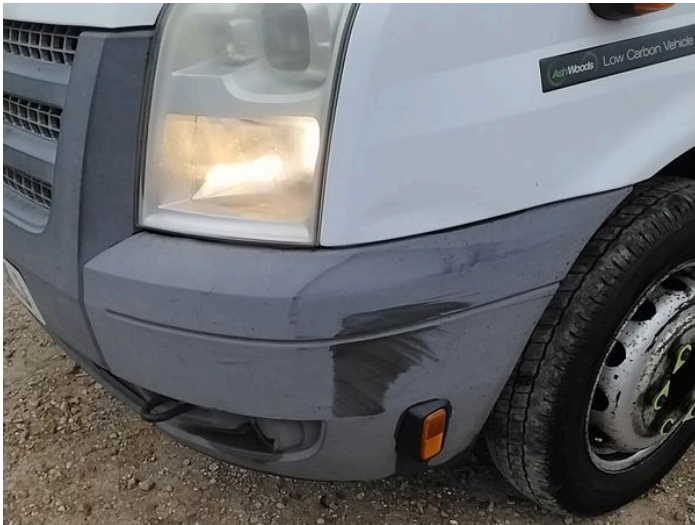
5: Bumper Front Moulding  
Scuffed (Unpainted)  
Over 100mm

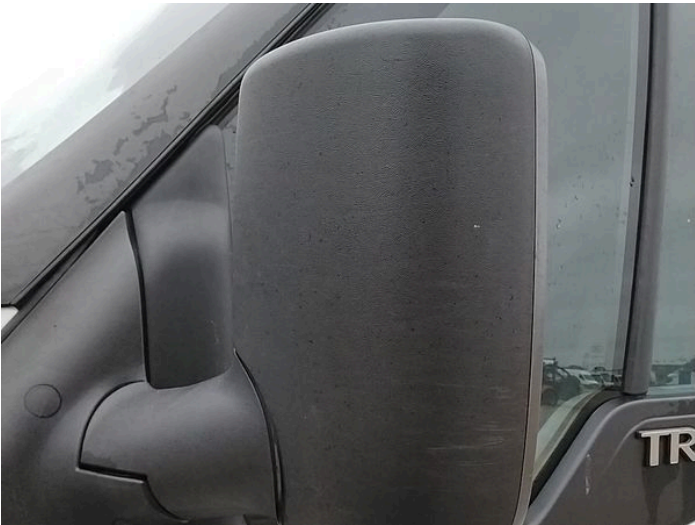
6: Door Mirror Assy nsf  
Scuffed (Unpainted)  
UpTo 100mm

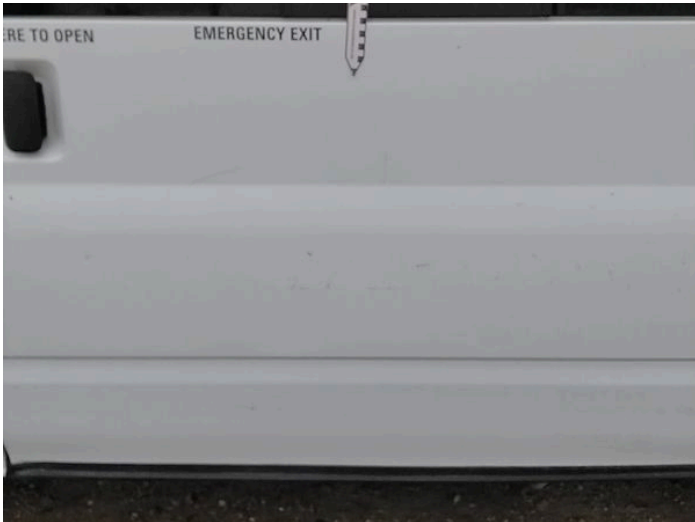
7: Door nsr  
Scratched  
Over 25mm Thru Paint

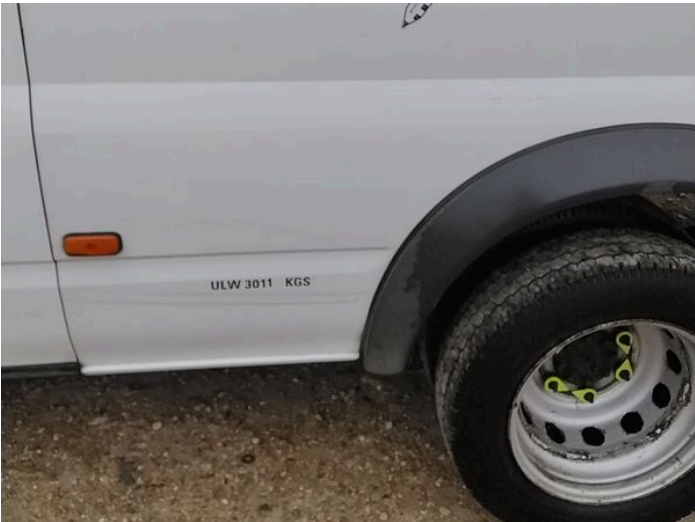
8: Qtr Panel nsr  
Scratched  
Over 25mm Not Thru Paint

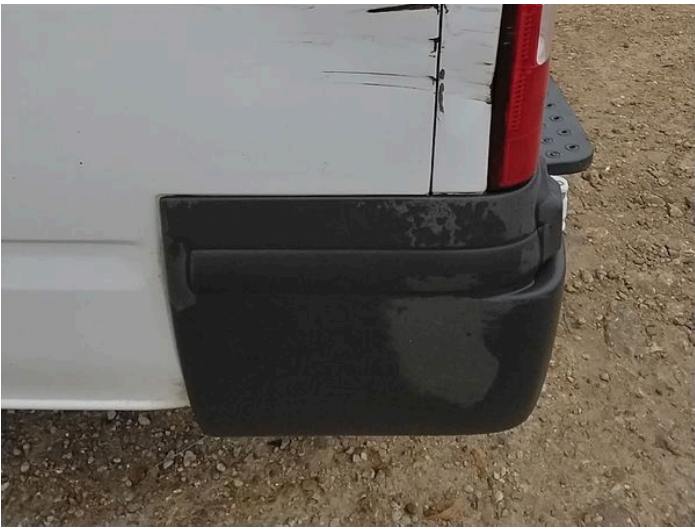
9: Qtr Panel nsr  
Dented  
With Paint Damage

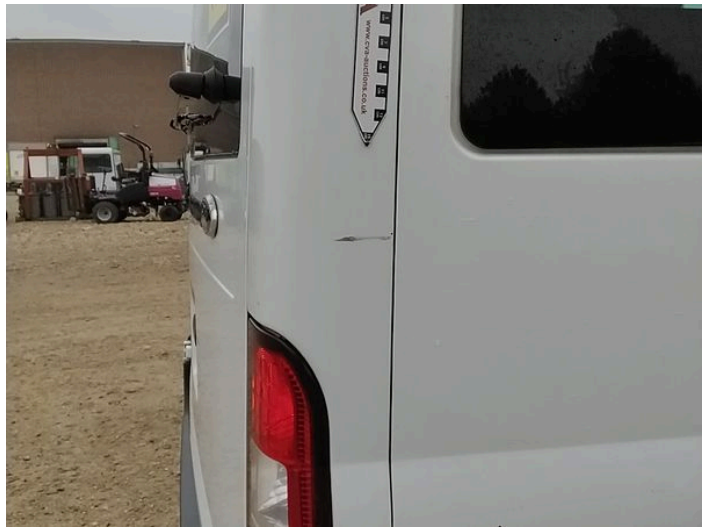
10: Qtr Panel osr  
Scratched  
UpTo 25mm Not Thru Paint

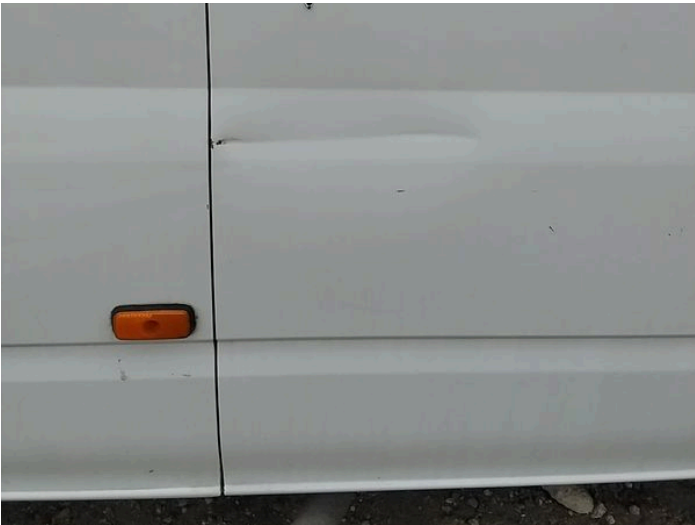
11: Qtr Panel osr  
Dented  
With Paint Damage

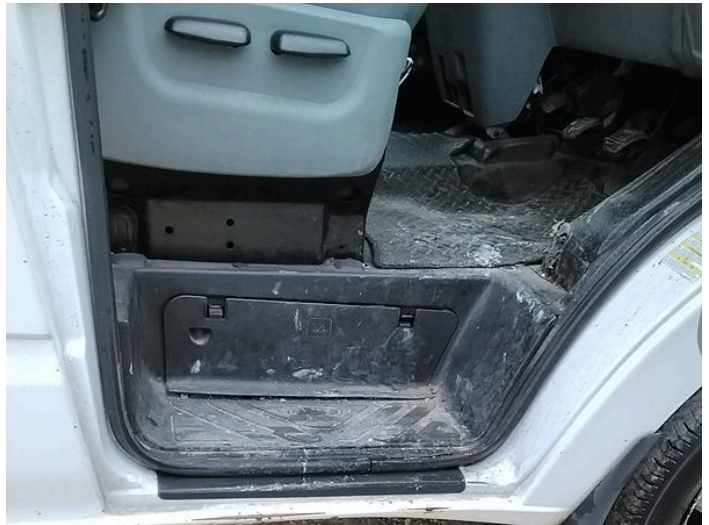
12: Sill os  
Scratched  
Over 25mm Thru Paint

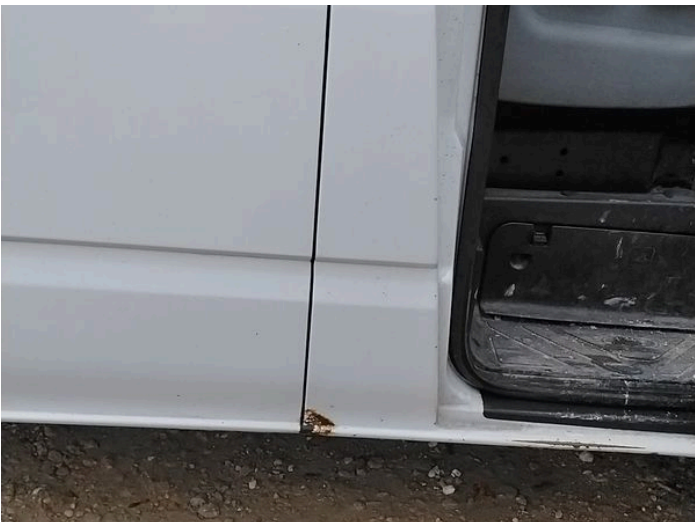
13: B Post os  
Rusted  
Over 5mm
